**COMPOSITE ACTION IN A STEEL GIRDER SPAN WITH PRECAST DECK PANELS:
THE I-81 BRIDGE OVER THE NEW RIVER IN RADFORD, VIRGINIA**

October 2003
VTRC 04-R4

Two parallel bridges carry I-81 north and south over the New River in southwest Virginia, near the city of Radford. The bridges are identical in design and have been in place since 1985. In recent years, a number of maintenance issues have been reported, primarily related to cracking of the cast-in-place topping over partial-depth precast deck panels.

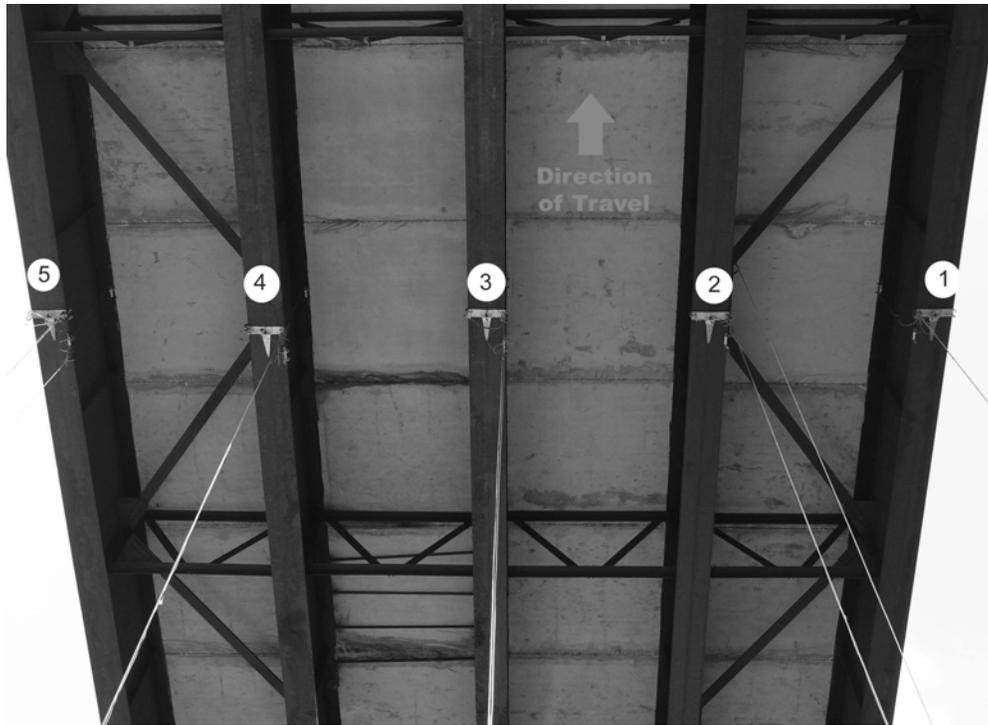
Figure 3. Strain and Displacement Gages at Midspan of Span 8 NBL

As in the previous field test conducted in August 2000, weigh-in-motion (WIM) strain gages were used to measure mid-span strain in the longitudinal direction in the top and bottom flanges of each of the five girders of Span 8 NBL (see Figure 3). The length of this span was 170 ft. In addition, vertical displacement gages were used to determine simultaneous real-time deflection of each girder under load. The data were logged for later analysis and comparison to previous field tests. The data sample rate was 1,200 readings per second for all gages.

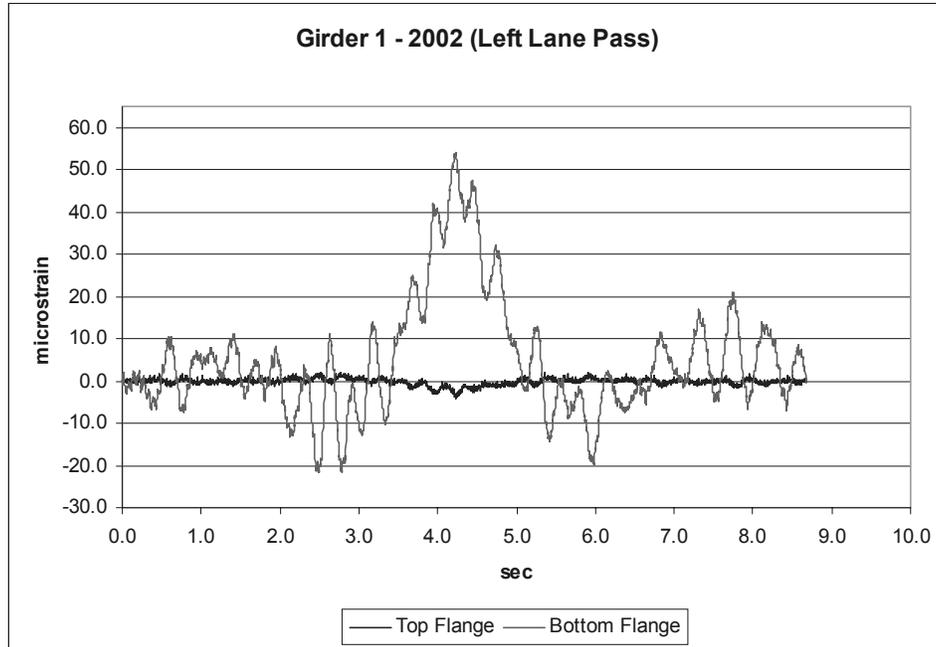
Figure 4. Typical Strain Response from Load Test

The peak tensile strains in the bottom flange of each girder were derived from the strain data obtained during a given pass. For the four passes evaluated, Table 1 presents the peak tensile strain in each girder and some simple statistics about the data. The greatest strain noted was approximately 71 microstrain ($\mu\text{m}/\text{m}$). Assuming a modulus of elasticity for the steel in the girder of 29×10^6 psi, the corresponding maximum observed stress would be approximately 2.06 ksi, which is considered a very low stress for this material and presents no danger of yielding.

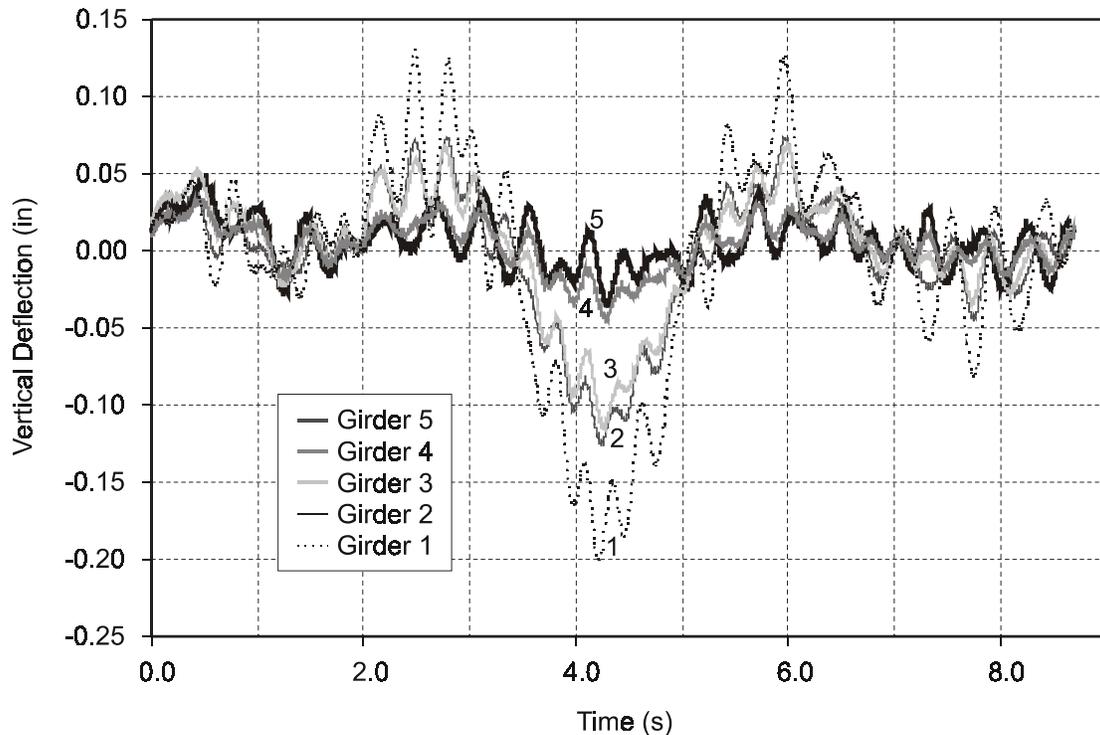
Figure 5. Typical Plot of Girder Deflection During Left Lane Pass

Because of the heavy truck traffic on the bridge (which essentially meant the bridge vibrated continuously during the measurements), the accuracy of the discussed measurements was less than desired. The vibration of the bridge resulted in “at rest” strain measurements of as much as ± 25 microstrain and deflection measurements of ± 0.1 in. This effect was included in the analysis of the data, which resulted in the elimination of some truck crossings and data from inclusion. Figure 5 is a typical plot of girder deflections, as measured during a left-lane pass.
